Inspector's Daily Report

IDR Sheet 1 of 2 Sheets		
Contract C-7852	Day Wednesday	Date July 14, 2010

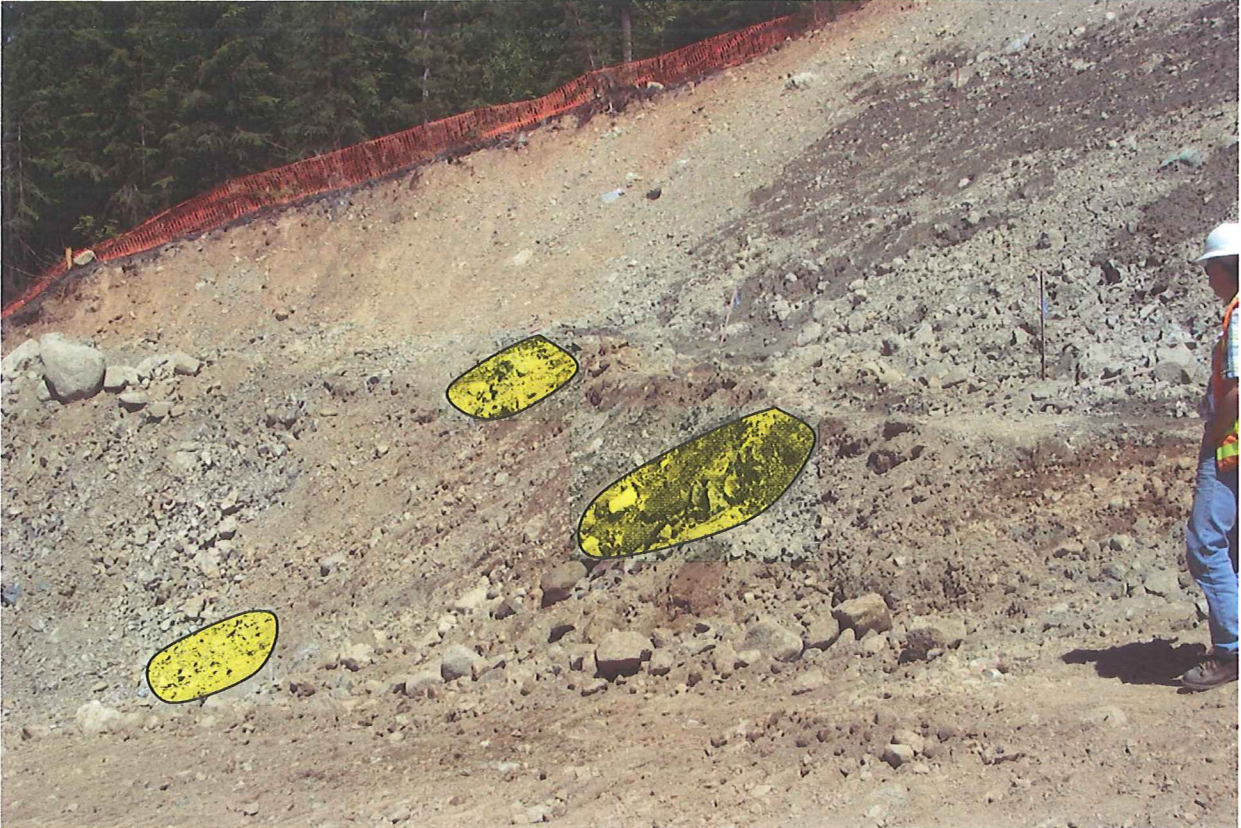
We discovered that much of the cut face was covered with soil debris and we were not able to see the preshear line (Figure 1). A small area of bedrock was exposed along the crest near 1315+75, but no preshear holes were visible. Bedrock was also apparent near the base of the east end of the excavation near 1315+00. A 5 to 7-ft-wide bench was preserved where the preshear line had been drilled. Brad said that Charley Murphy with Western States was certain that they had excavated to the preshear line and was concerned that rock was not present in the planned cut face. We spoke with Lonnie (Western States personnel), who informed us that the preshear line should be very close to 5 ft offset from the stakes on the bench. We collectively agreed that they likely had not yet excavated far enough. We recommended to Brad that the contractor excavate another 1 to 2 feet of the slope to investigate for the 0.5H:1V preshear line.

Figure 1. Newly excavated cut between Stations 1315+00 and 1315+75. Shaded yellow areas appeared to be areas of bedrock exposure.

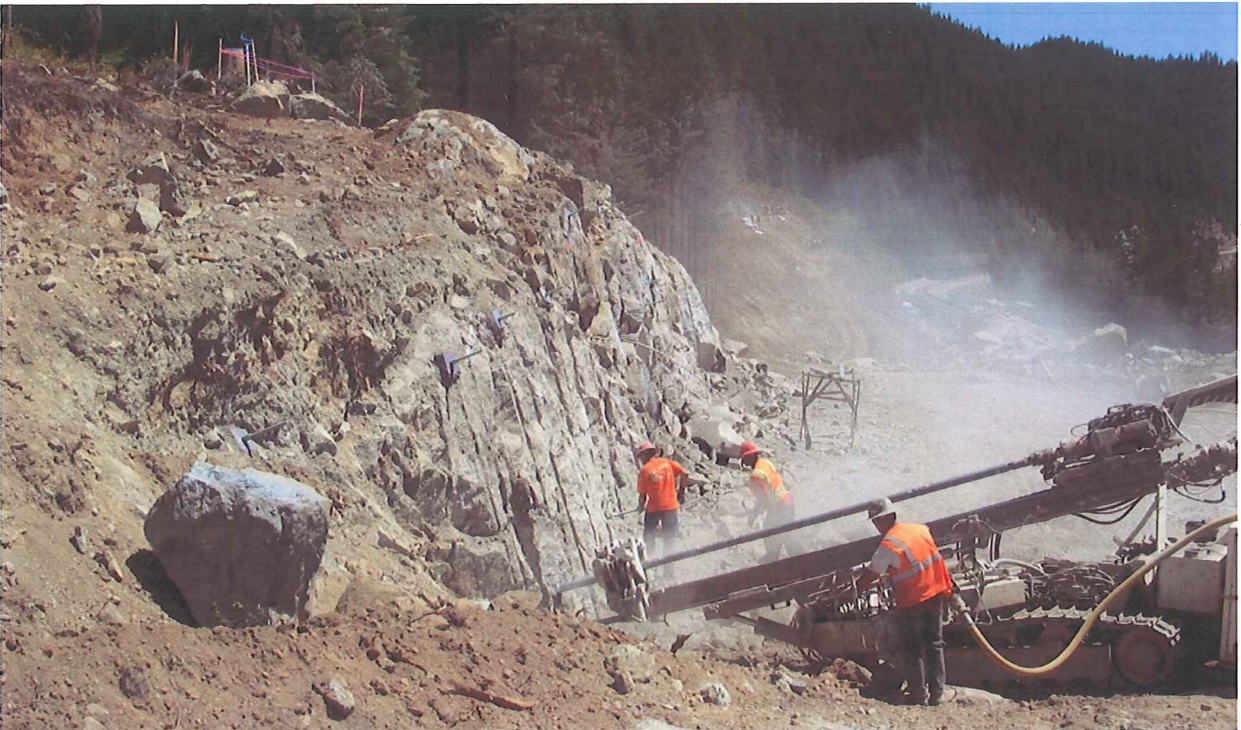
We observed the drilling and grouting of the type L dowels by Cascade NW at Station 1337 (Figure 2). Some of the dowels were located about 9 feet above the working bench, and the contractor reportedly had no difficulty reaching them, as had previously been claimed. We observed some grout loss from fractures in the face. Brad had directed the contractor to stop grouting when this occurs, and allow the grout to cure, and then try grout again to get full coverage of the bars. We took several measurements of discontinuity orientations in this vicinity to track geologic structures newly exposed in the cuts. We painted marks on the measured surfaces, and requested Brad and Jerry to have the survey crew provide us coordinates for four points (A,B, D and E).

Figure 2. Dowels at Station 1337 were successfully installed at heights up to 9 feet above the working bench.
